SERVICE BULLETIN

APPLICABILITY: 2012 - 13MY Impreza Models with 2.0L FB Engines 2013MY XV Crosstrek

NUMBER:
 02-145-13R

SUBJECT: Surface Treatment Change To Oil Control Piston Rings

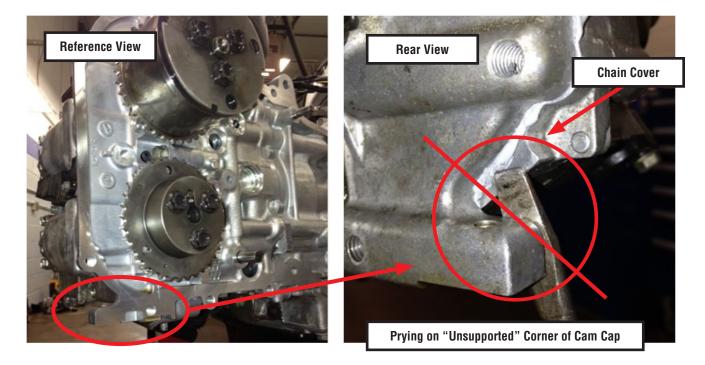
• **IMPORTANT:** After all 32 bolts securing the chain cover are removed, be **VERY** careful where you pry and what you pry on to break the silicone sealant bond. The photos below show an example of where NOT to pry. In this case, the cam cap became cracked requiring a complete cam carrier replacement. Patience is the key!

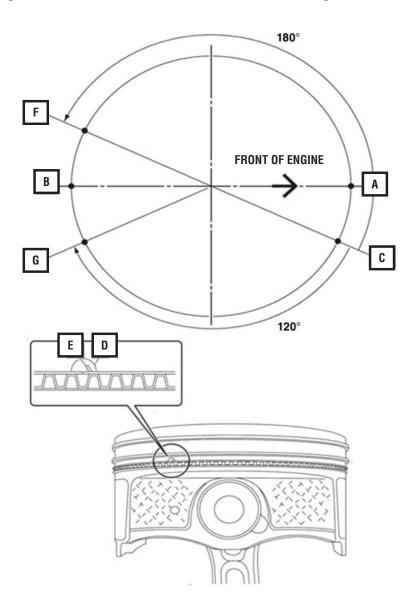
- "A"- Top compression ring end gap location
- "B"- Second compression ring end gap location (180 degrees away from "A")
- "C"- Top oil control scraper ring end gap
- "D"- Recess in top of ring land to accept the "tang" of the upper oil control scraper ring "E"
- "F" Expander gap (180 degrees away from "C")
- "G" Bottom oil control scraper ring end gap (120 degrees away from "C")

When cleaning the pistons prior to installing the new rings, take care not to damage the antifriction coating applied to the skirts. A mild parts cleaner may also be used with the Scotch-Brite Ultra-Fine #7448 (gray in color) to loosen and remove carbon deposits from the piston crown and from between the ring lands. Do not use Scotch-Brite to clean the piston skirts as it can damage the anti-friction coating. The ends of a removed compression ring may be used to carefully clean deposits from inside the ring lands. Rinse the piston / rod assemblies thoroughly and dry before installing the new rings onto the pistons. Refer to the Service Manual and the illustrations below for ring direction (marks facing upward) and end gap placements. Remember to lubricate the rings, piston skirts, cylinder walls, wrist pin areas, rod bearing surfaces and rod bolt heads and threads with engine oil before reassembly.
