Surface Treatment Change To Oil Control Piston Rings

2013-2014 Subaru Legacy and Outback Models with 2.5L FB Engine

2011-2014 Subaru Forester Models with 2.5L FB Engines

2012-2013 Subaru Impreza and 2013MY XV Crosstrek Models with 2.0L FB Engine

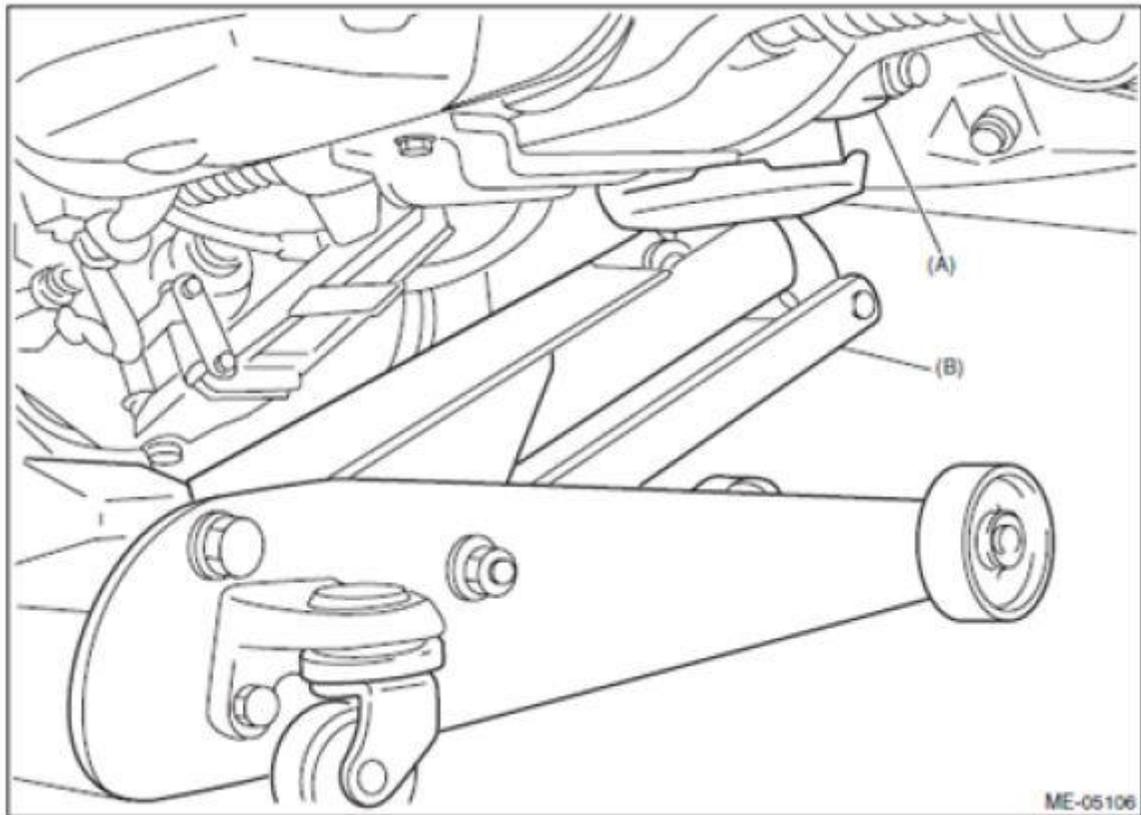
Raising it too high can push the transmission up into the bulkhead / transmission tunnel and possibly cause damage.

raising the transmission with the service jack

- When removing the engine, there is no need to remove the transmission case cover (CVT only) or to disconnect / disturb any of the transmission harness connectors. While raising the transmission with the service jack placed under the front differential as shown in the illustration below, only raise it enough to access and remove the engine mounting hardware.

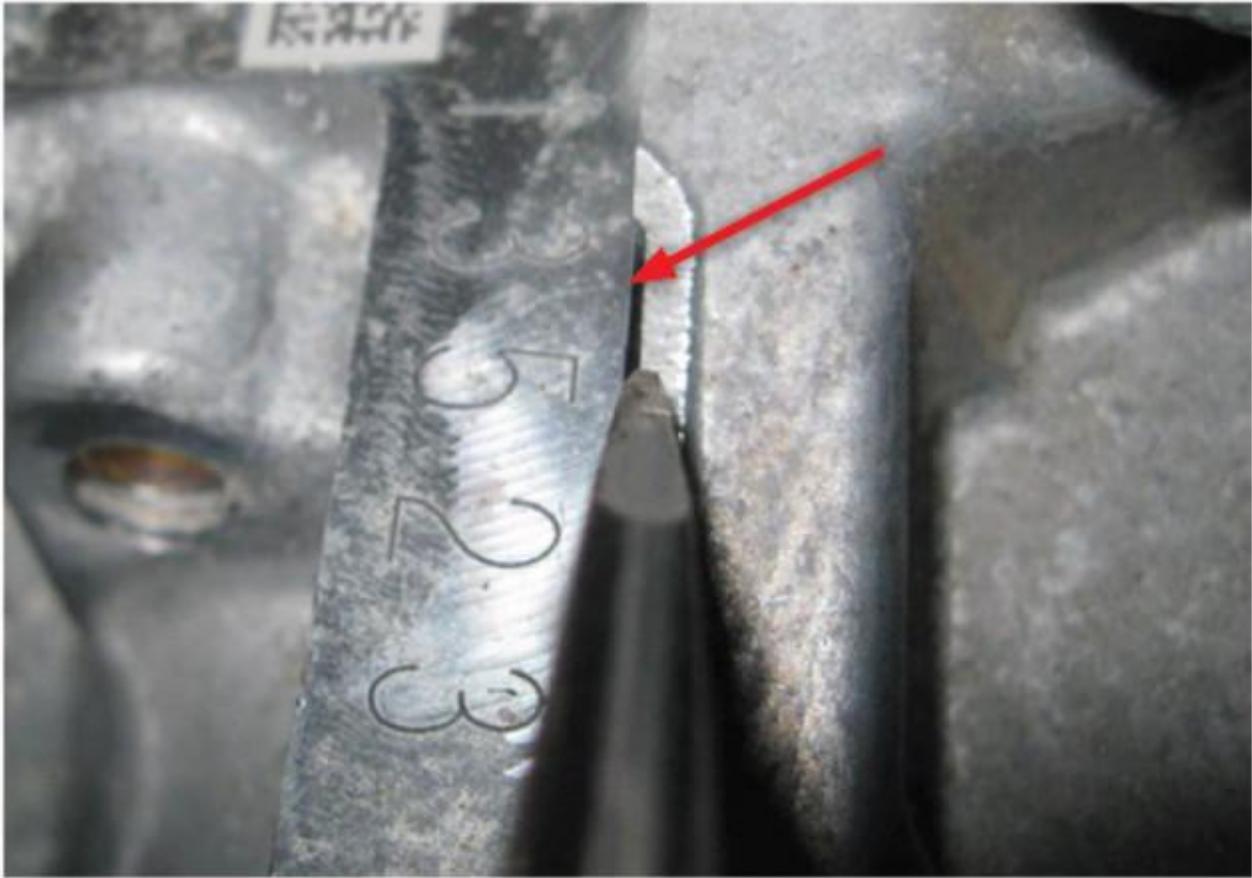
separating the transmission (CVT) from the engine pry relief

- To make separating the transmission (CVT) from the engine easier, there is a pry relief shown below in the machined mounting surface of the transmission case near the engine number. Use caution when applying any prying pressure and avoid twisting the tool to prevent case damage.

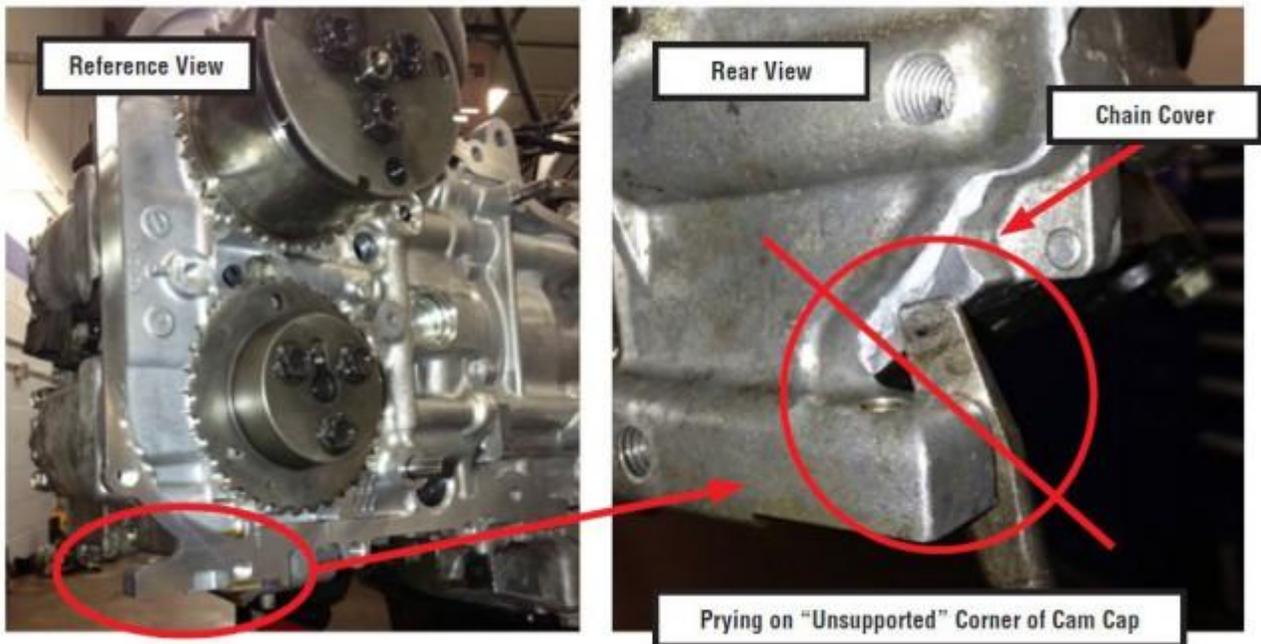
- **IMPORTANT:** After all 32 bolts securing the chain cover are removed, be **EXTREMELY** careful where you pry and what you pry on to break the silicone sealant's bond. The photos below show an example of where **NOT** to pry. In this case, the cam cap became cracked requiring a complete cam carrier replacement. Patience is the key!

cam cap became cracked
requiring a complete cam carrier replacement

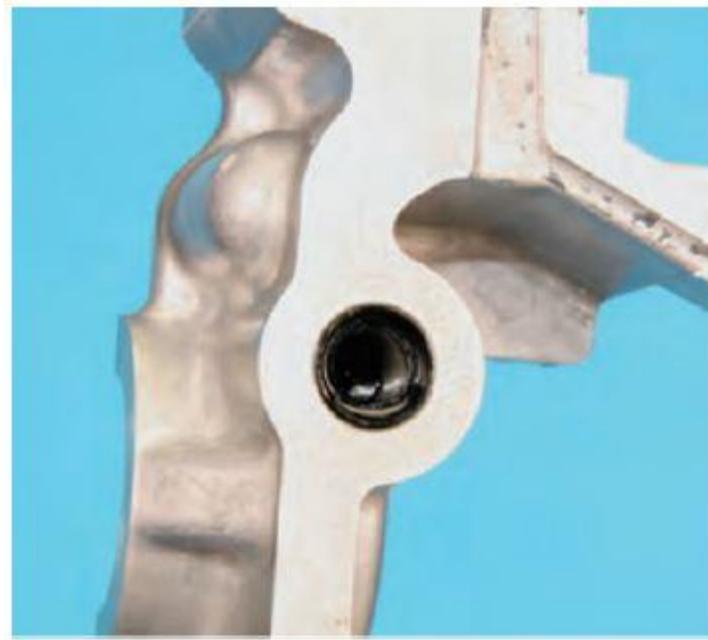
AVCS filter screen

• **IMPORTANT:** If by chance the AVCS filter screens in the cam carriers have come loose or fallen out during disassembly, they are directional and **MUST** be reinstalled in their original position. There is an oil passage in the cam case which **MUST** align with a hole on the outside diameter of the filter screen tube otherwise, oil flow to the AVCS will be restricted or blocked resulting in engine damage.
