SERVICE BULLETIN

APPLICABILITY: 2013-14MY Legacy and Outback Models
 with 2.5L FB Engines
 2011-14MY Forester Models with 2.5L FB Engines
 2015 MY Forester (Manual Transmissions Only)
 with 2.5L FB Engines
 2012-13 MY Impreza and XV Crosstrek Models
 with 2.0 FB Engines
 2014-15 MY Impreza and XV Crosstrek Models
 (Manual Transmissions Only) with 2.0 FB Engines

NUMBER: 02-157-14R

SUBJECT: Surface Treatment Change To Oil Control
 Piston Rings

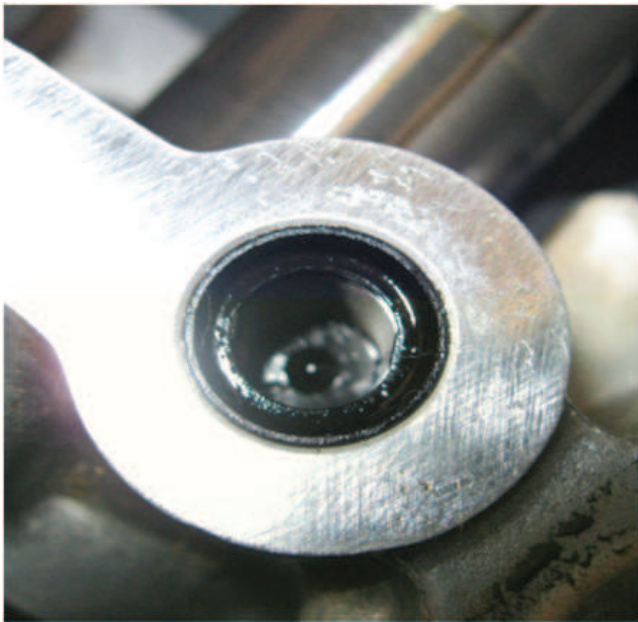
Cam Carrier Filter Screen

- Don't forget to thoroughly clean (**without removing**) the filter screens in the cam carriers. In addition, always be sure to do a thorough inspection and cleaning of the oil pan, pick-up tube and screen as shown in the photos below before reassembly.

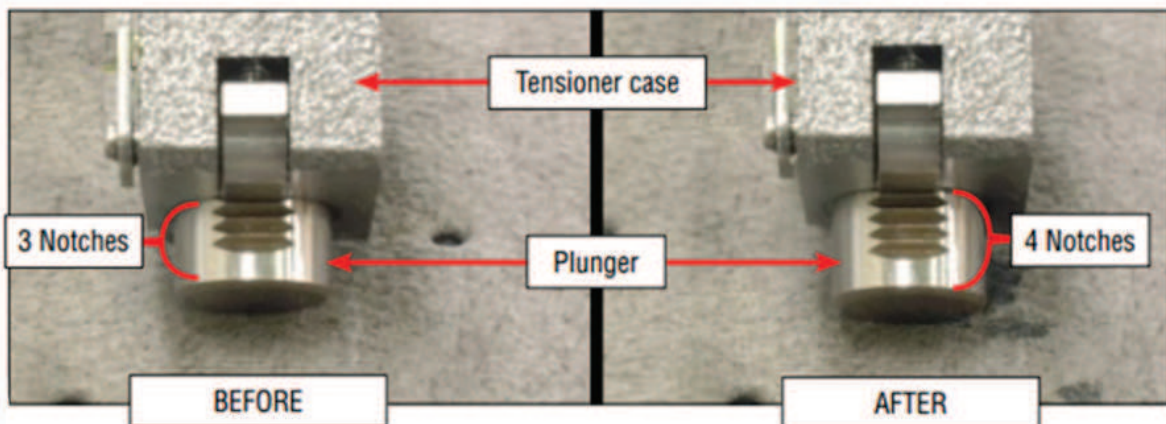
- If you have 3 notches showing, you want to get one more “click” so that 4 notches are visible as shown in the photos below. If you have 4 showing, you want to end up with 5. Whether you start with 3 or 4 will depend on the amount of wear present on the chains and guides. The number of clicks listed here is simply a guide. The point is to ensure proper initial chain tension is applied to avoid creating a brief rattle sound at engine start.

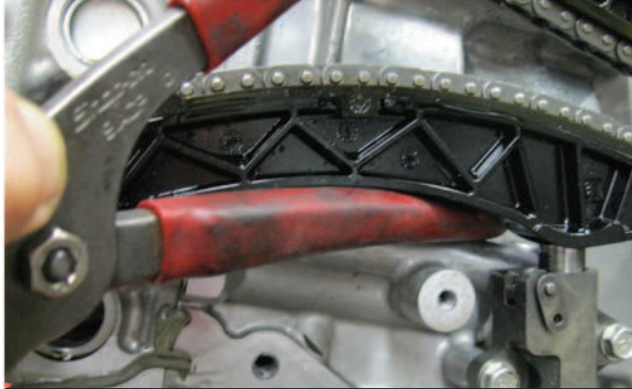
Rubber-coated plier handle inserted between a ledge area on the front of the block and the B1 lower chain guide **VERY CAREFULLY** lifting upward on the lower guide.

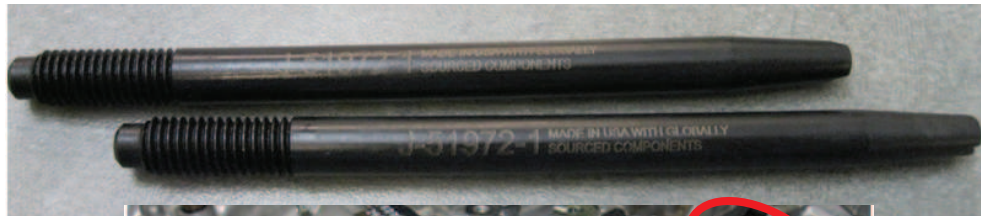
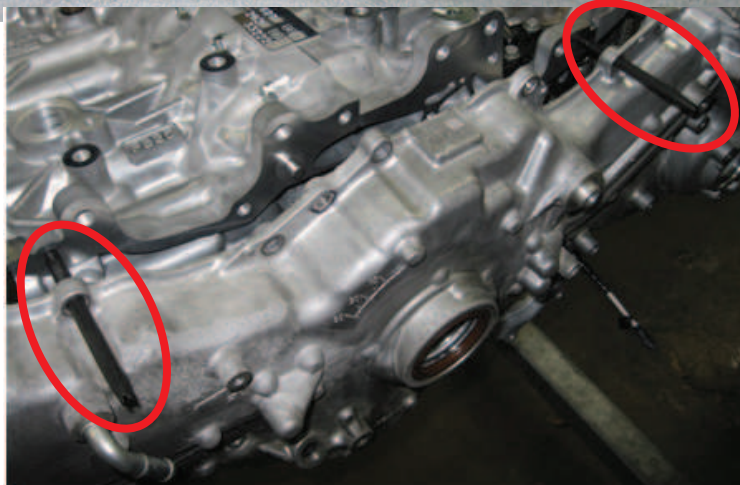
- **IMPORTANT:** When re-installing the front cover assembly, be very careful to not allow it to contact any of the timing sprockets. If contact does occur, it will most likely be with the exhaust sprockets and it is almost a guarantee the fresh silicone sealer beads applied to the cover will be disturbed. To minimize the possibility of this happening, alignment pins as shown in the photos below have been developed to “guide” the cover into its proper position without disturbing the fresh sealer. The Subaru Special Tool number for the alignment pin kit is J-51972. Each kit includes 2 pins.

- If alignment pins are not used and the sealer gets disturbed during the cover installation, unless properly addressed, the affected area(s) will most likely be the source of an oil leak after reassembly. Don't hesitate to use a helper for the cover installation to prevent this from happening.
