Surface Treatment Change To Oil Control Piston Rings

2013-2014 Subaru Legacy and Outback Models with 2.5L FB Engine

2011-2014 Subaru Forester Models with 2.5L FB Engines

2012-2013 Subaru Impreza and 2013MY XV Crosstrek Models with 2.0L FB Engine

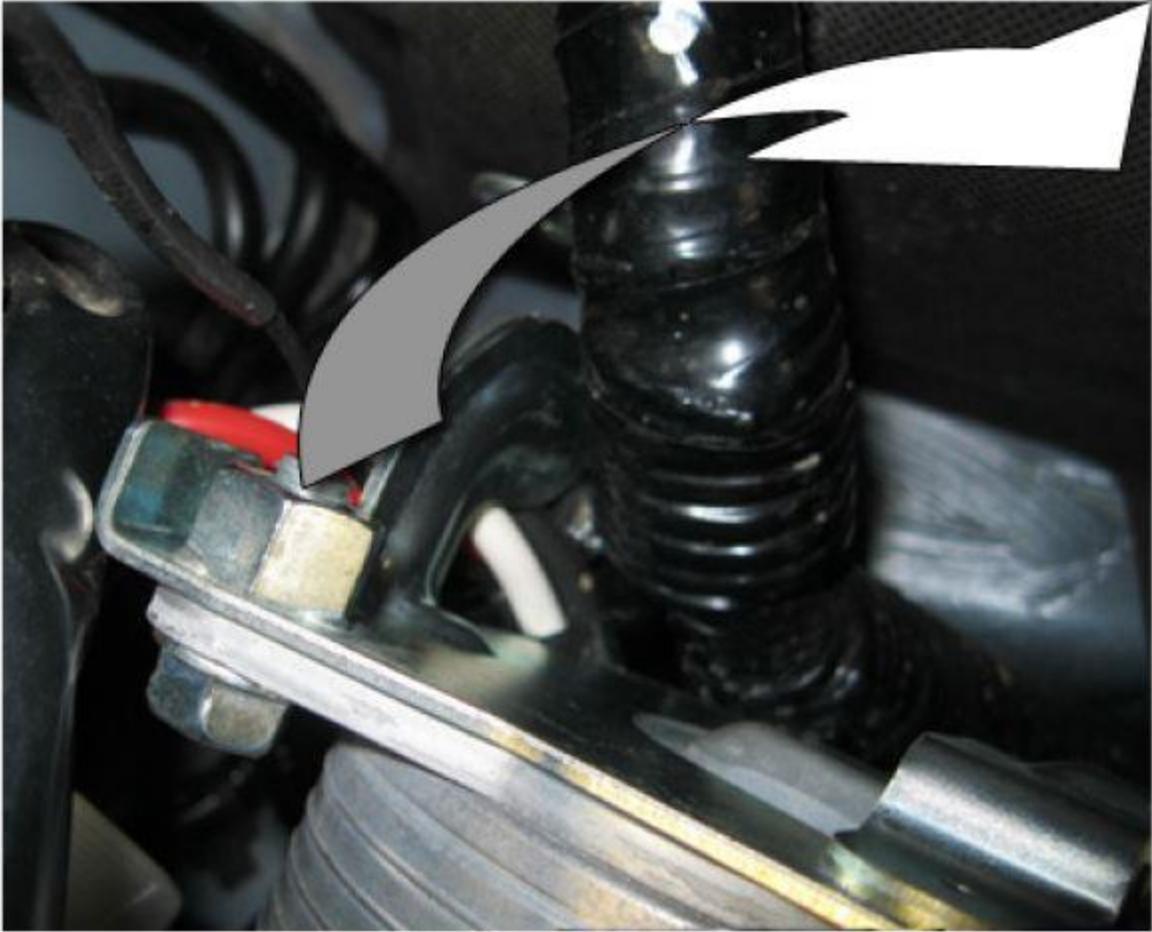
keep the cooler assembly out of your way

- When removing the CVT fluid cooler (if equipped), leave it attached to its mounting bracket and remove as an assembly (3 bolts) from the transmission. Disconnect just the engine coolant hoses from it and do not disturb the 2 short CVT fluid lines. Hook one of the cooler's mounting bracket "ears" behind the bulkhead harness as shown in the photo below to keep the cooler assembly out of your way. Use a shop cloth between the "ear" and the bulkhead harness to prevent any chafing.

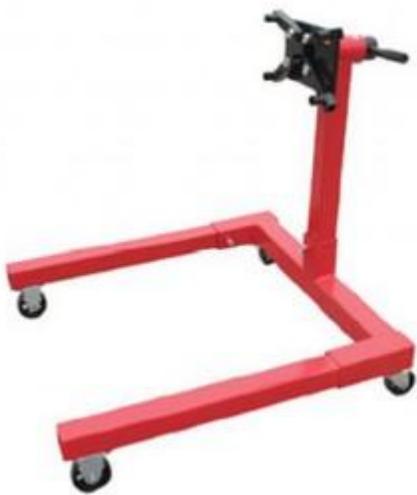
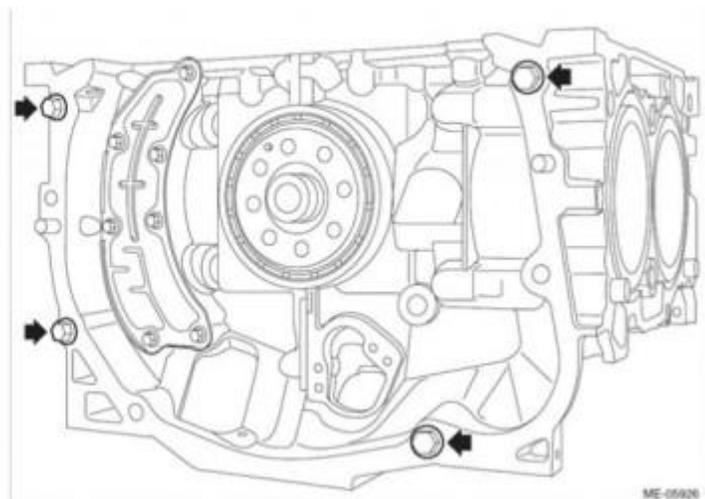
- Once the engine is removed, if you are using a generic engine stand (preferable since engine rotation is necessary), use the four mounting holes on the engine block shown below to mount it. NOTE: Do not use the mounting studs in the upper oil pan.

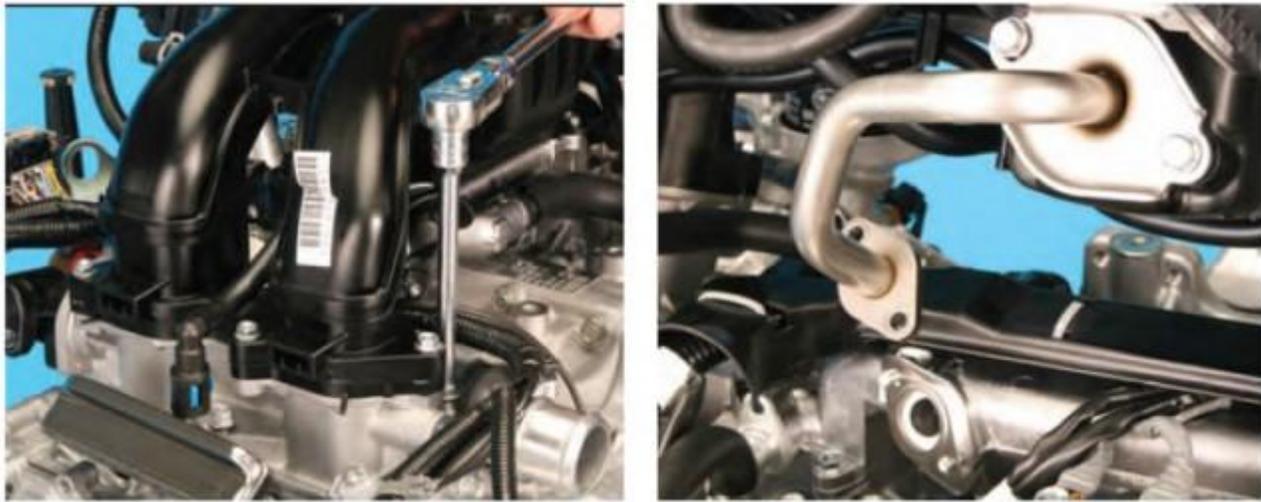
- When removing the intake manifold, as shown in the photos below, leave the TGV assemblies attached to the upper intake, remove the 2 nuts holding the EGR tube to the water pipe then remove the complete assembly from the cylinder heads as a unit.

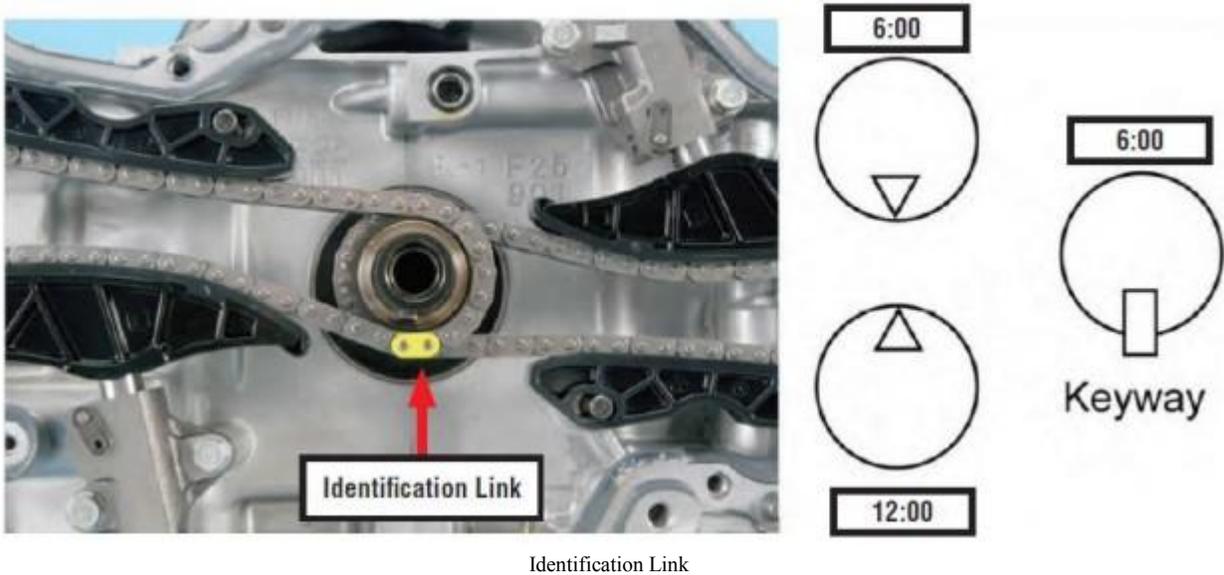
- Begin timing chain removal by positioning the crankshaft keyway at the 6:00 position. The RIGHT bank intake camshaft timing mark (Δ) must be at 6:00 with right bank exhaust timing mark at 12:00 (camshafts will be unloaded).

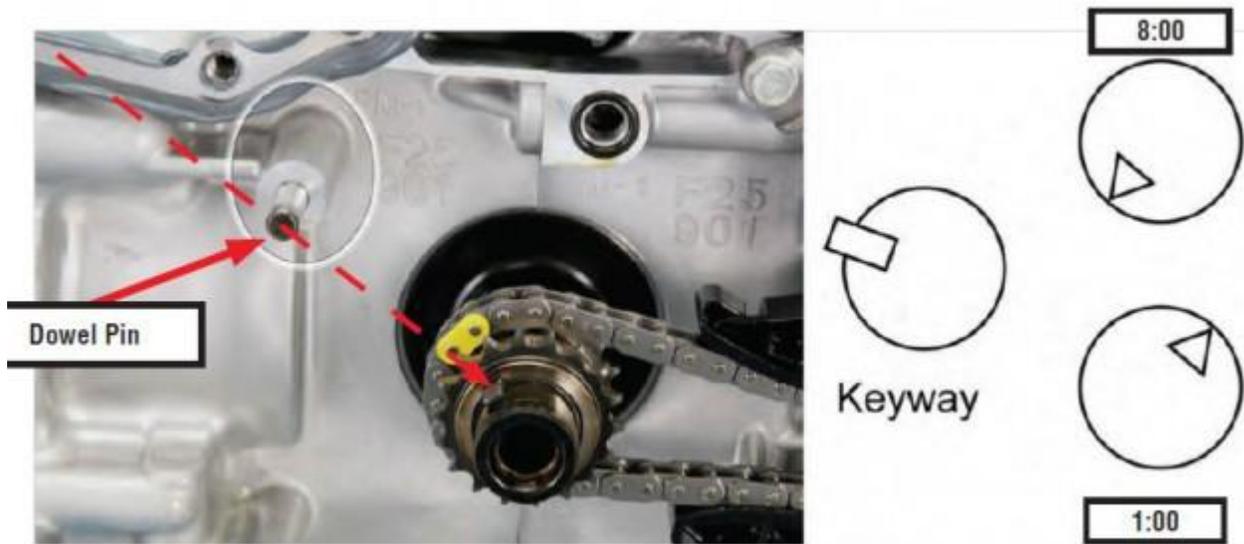
Align the crank sprocket keyway with RH chain dowl pin

- After turning the crankshaft CLOCKWISE, repeat the procedure for the LEFT side with the timing marks (Δ) positioned as shown below. Align the crank sprocket keyway with RH chain dowel pin (shown in red below).

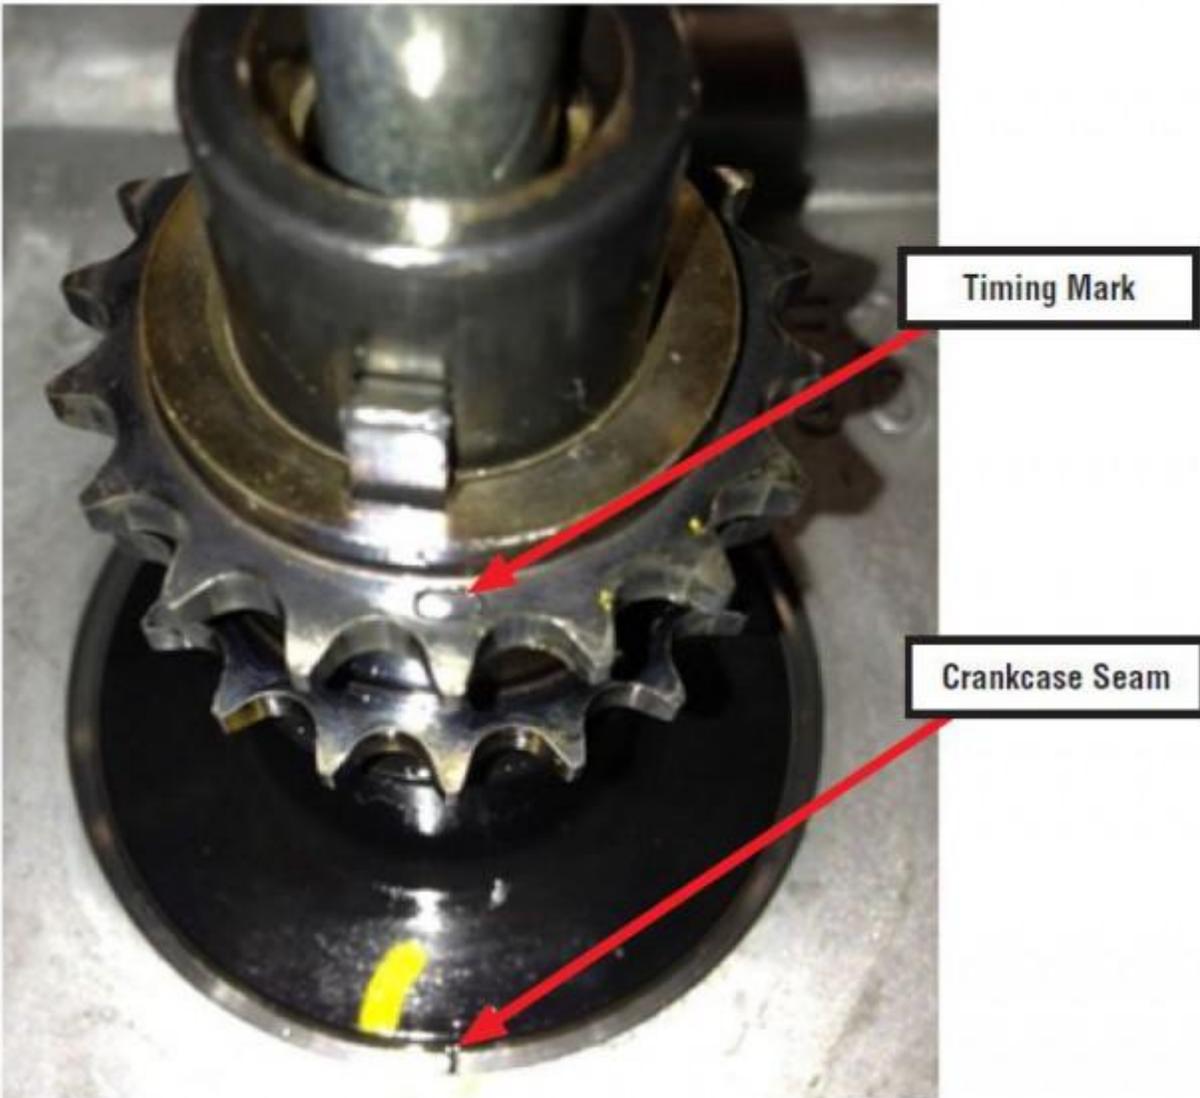
- After the left chain is removed, turn the crankshaft in a COUNTER CLOCKWISE direction until the timing mark on the crankshaft sprocket (NOT the keyway) is back to the 6:00 position as shown below. This positions all the pistons away from TDC and prevents accidental contact between the pistons and valves.

This positions all the pistons away from TDC and prevents accidental contact between the pistons and valves

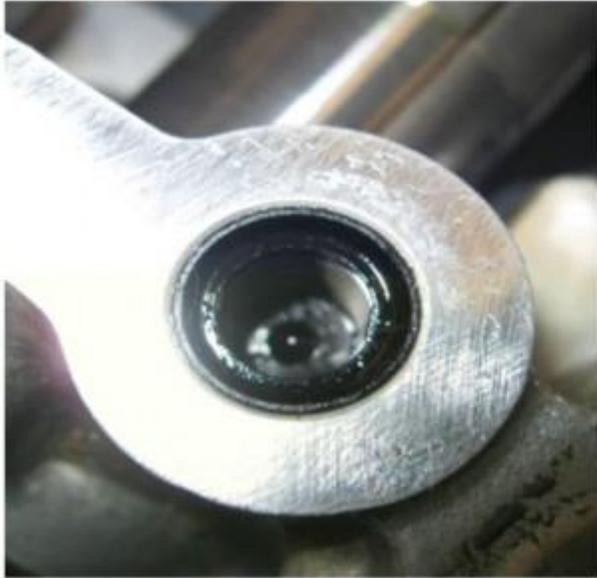
Cam Carrier Filter Screen

- Don't forget to clean (without removing) the filter screens in the cam carriers (one filter in each carrier). In addition, always be sure to do a thorough inspection and cleaning of the oil pan, pick-up tube and screen as shown in the photos below before reassembly.

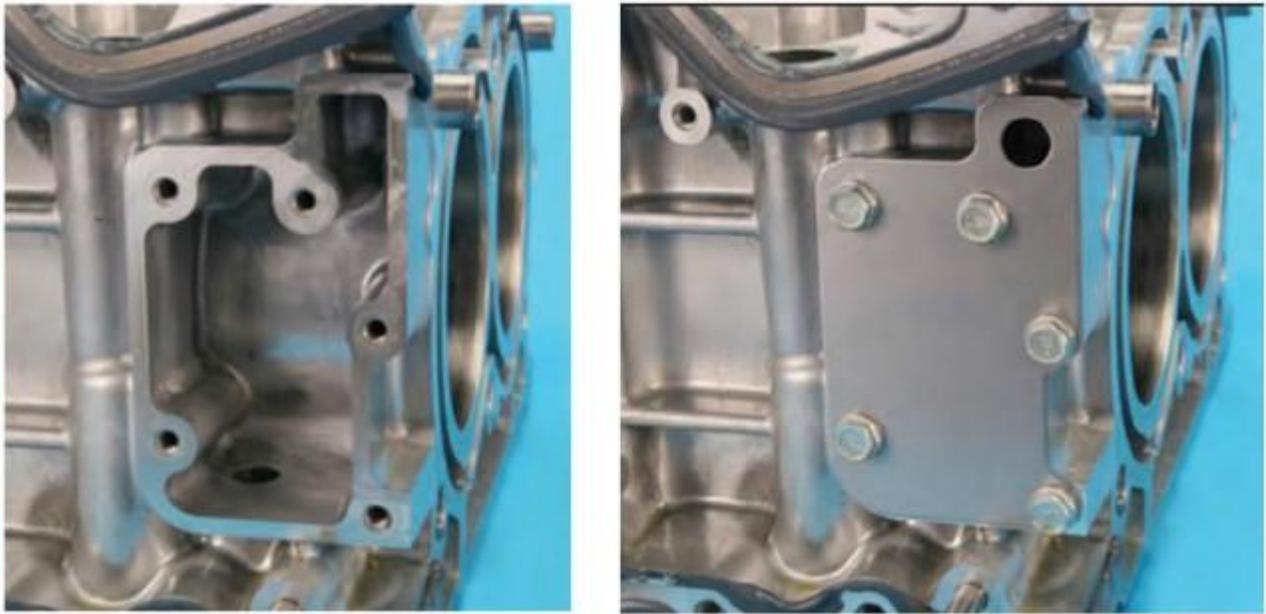
- Install the new one-time use PCV adapter. NOTE: Never try to reuse the original.
- Swap over the PCV assembly and the PCV baffle plate onto the front of the block.

NOTE: No sealer is used between the baffle plate and the block.

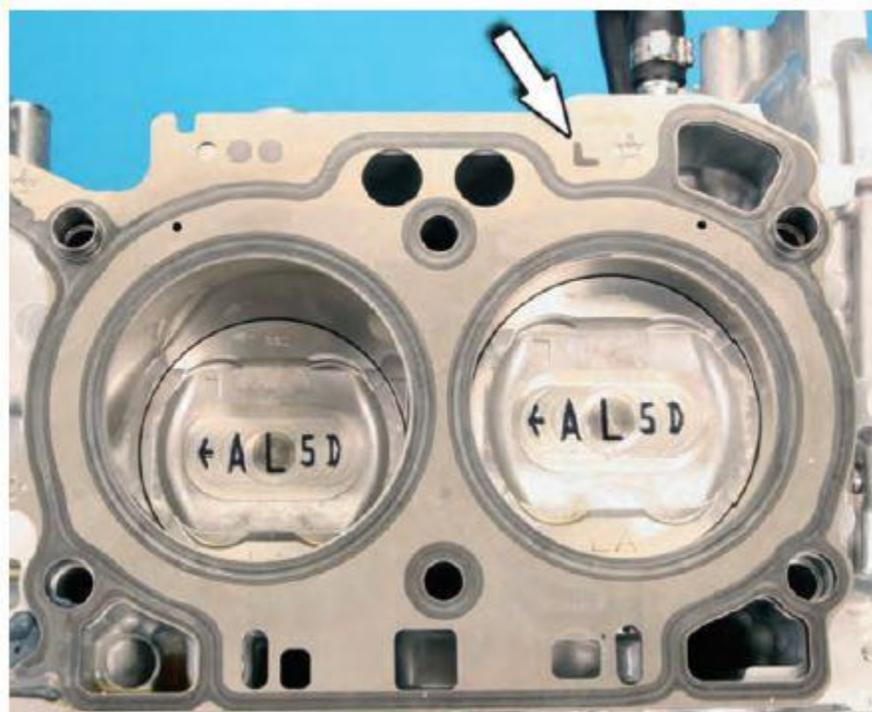
- If equipped, swap over the lower water jacket coolant baffles into the new block.
- Head gaskets are marked “L” and “R”. Always make sure they are properly installed while paying close attention to the sealer application areas as outlined in the Service Manual.

Head gaskets are marked “L” and “R”.

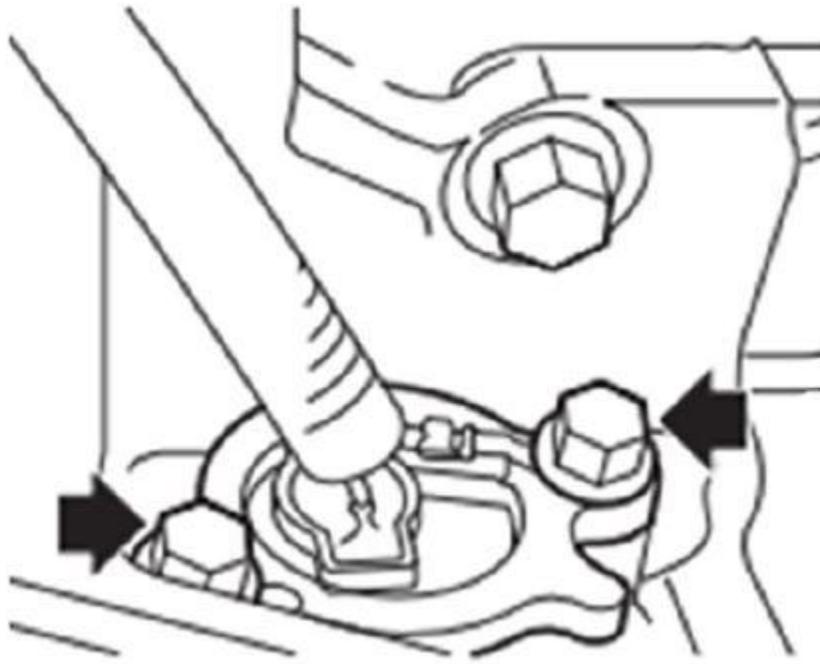
- Before installing the upper and lower oil pans, always thoroughly clean and inspect the pick-up tube and screen. Always use new o-rings on the pick-up tube and both oil pans during reassembly.
- After cleaning the upper oil pan assembly, replace the oil level switch assembly as shown in the illustration below. Torque the 2 retaining bolts to 6.4 Nm (56 inch-pounds).

IMPORTANT NOTE: At this time, this step for replacement of the oil level sensor is **NOT APPLICABLE** to 2012MY IMPREZA MODELS.

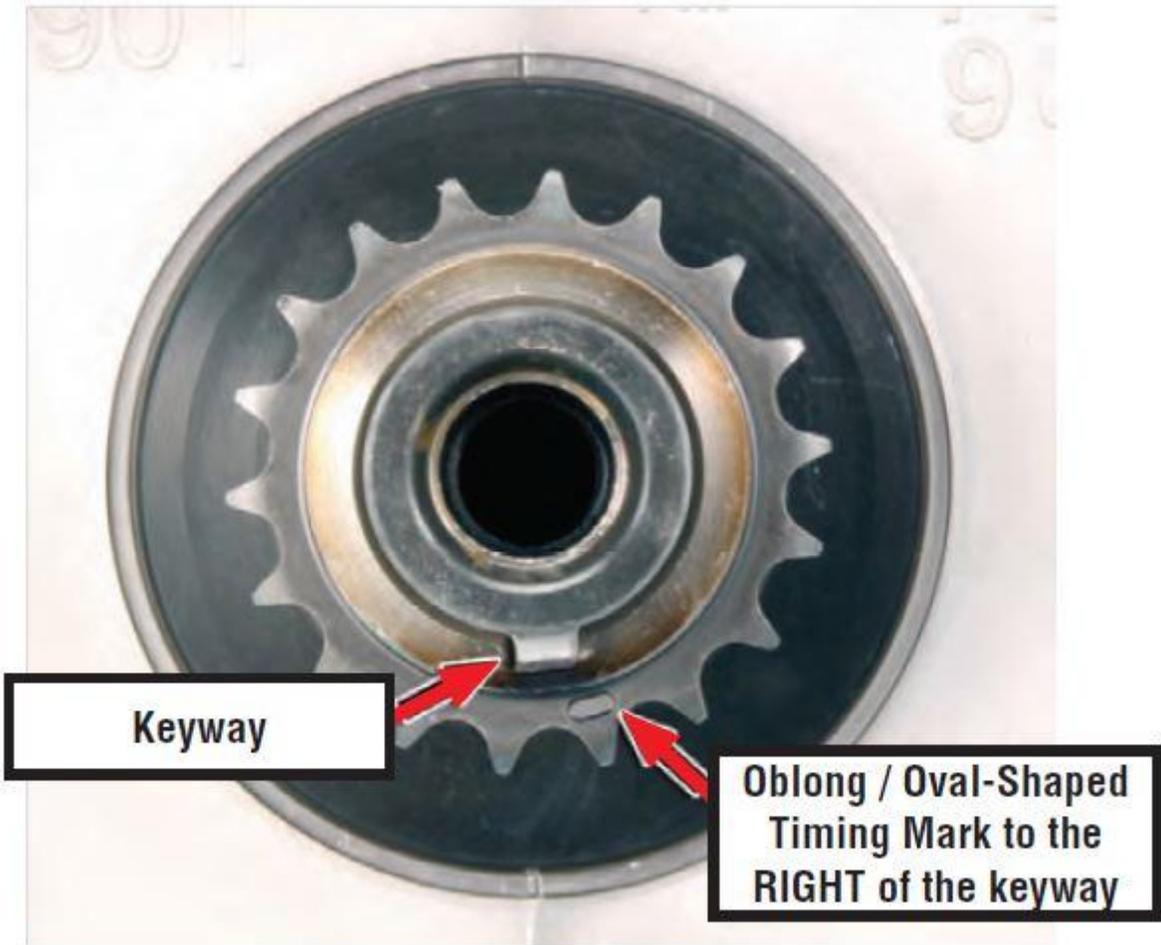
- To begin timing chain re-installation, turn the crankshaft **COUNTER-CLOCKWISE** until the crankshaft sprocket keyway is back to the 6:00 position. This positions the pistons away from TDC and prevents accidental contact with the valves. **NOTE:** The keyway is **NOT** a timing mark. The oblong / oval-shaped timing mark must face front and be to the **RIGHT** of the keyway as shown below. Do not confuse this mark with a mark which may be found on the back side of the sprocket.

Oblong / Oval-Shaped Timing Mark to the RIGHT of the keyway

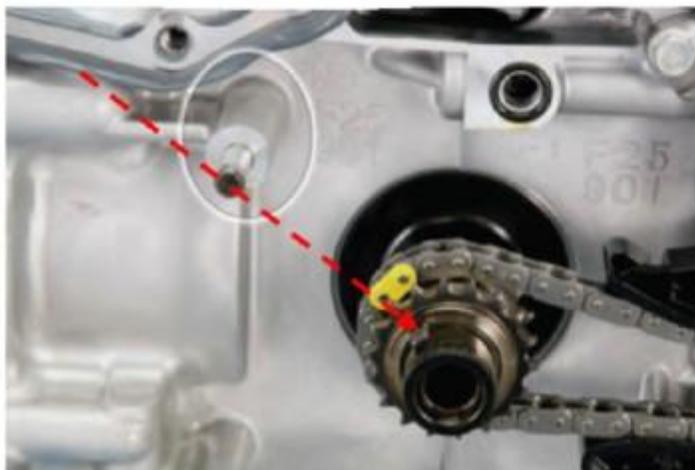
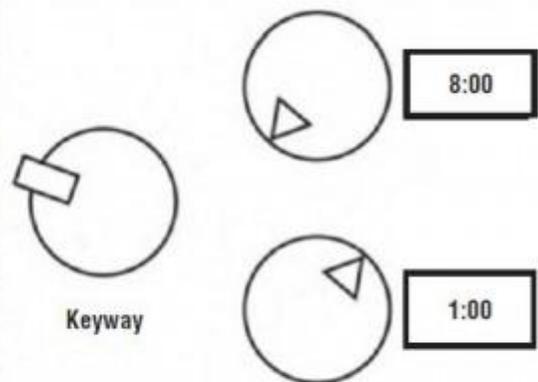
- Arrange the timing marks as shown below, turning the crankshaft CLOCKWISE into position. Align the indicator link with the timing mark on the crankshaft sprocket, keyway with the dowel pin.

indicator link with the timing mark on the crankshaft sprocket

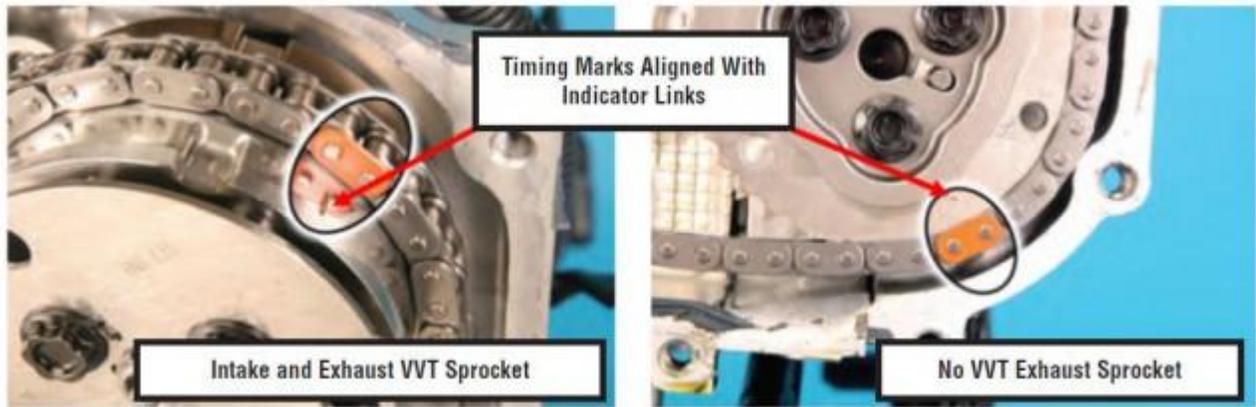
Timing Marks Aligned With Indicator Links

- Align the indicator links to the timing marks found on the outside of the sprocket assemblies as shown in the photos below (Exhaust sprocket face images vary with / without exhaust VVT).

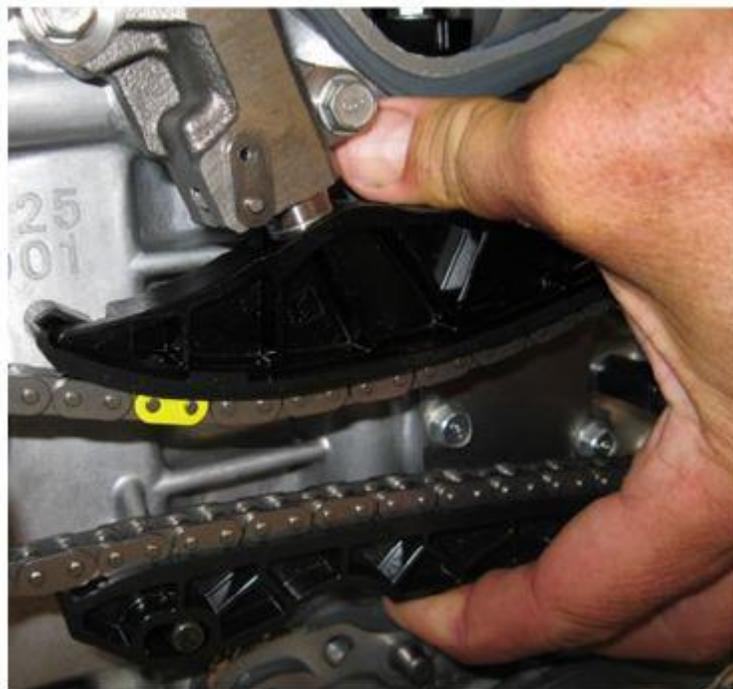
chain guides and tensioner

- Install the chain guides and tensioner. Once proper positioning has been confirmed, pull the pin to release the tensioner. With your hand, grab and squeeze the upper and lower chain / guides together as shown in the reference photo below to allow the plunger in the tensioner to fully extend and click into its furthest notch.

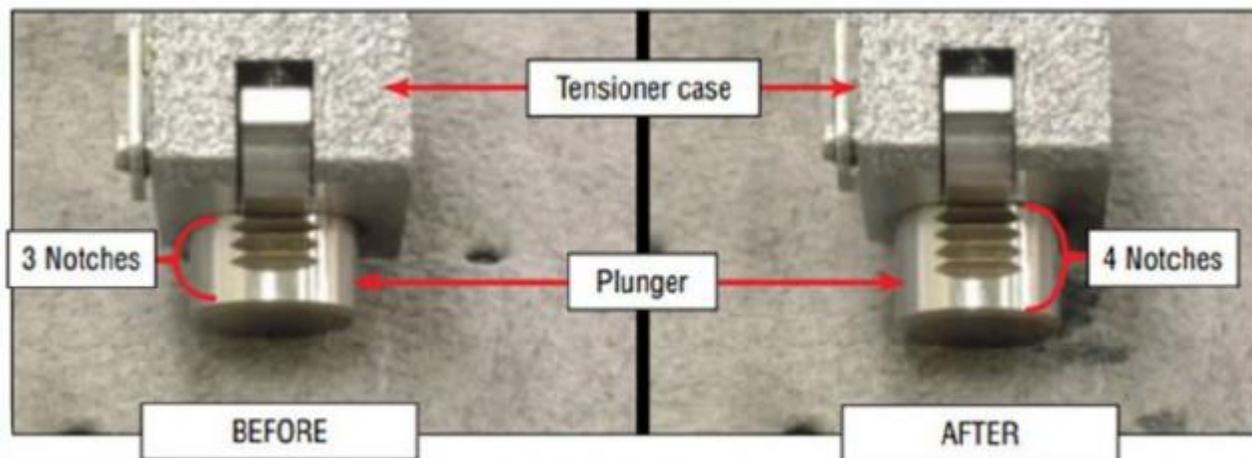
- If you have 3 notches showing, you want to get one more “click” so that 4 notches are visible as shown in the photos below. If you have 4 showing, you want to end up with 5. Whether you start with 3 or 4 will depend on the amount of wear present on the chains and guides. The number of clicks listed here is simply a guide. The point is to ensure proper initial chain tension is applied to avoid creating a brief rattle sound at engine start.

tension is applied to avoid creating a brief rattle sound at engine start

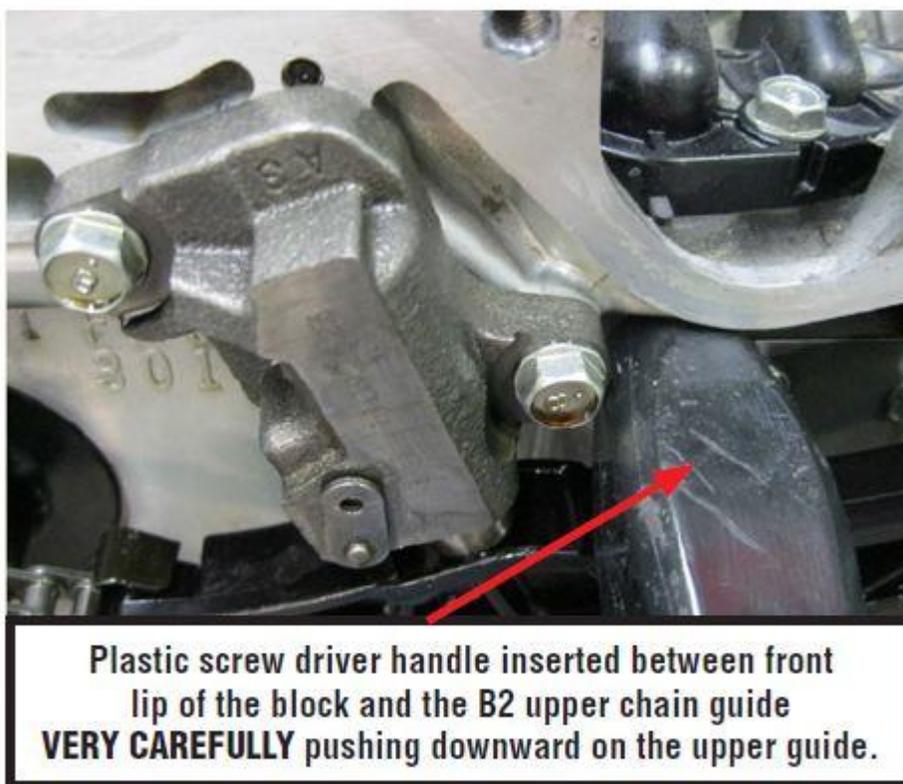
- If necessary, insert a plastic screwdriver handle between the lip of the block and the left side (B2) guide. Then, VERY CAREFULLY push down on the guide just enough to get the extra tensioner notch / “click”. When using this method, always make sure you are using plastic on plastic and NOT metal on plastic to avoid damaging the chain guides.

push down on the guide just enough to get the extra tensioner notch / “click”

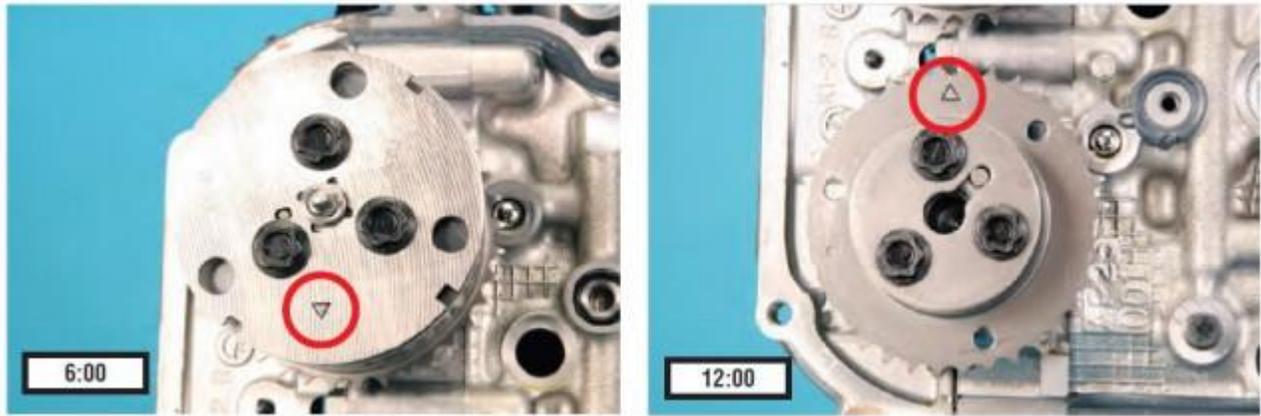
- Rotate the crankshaft COUNTER-CLOCKWISE until the crankshaft sprocket timing mark is at the 6:00 position. Position the cam sprocket timing marks as shown below; intake 6:00, exhaust 12:00.

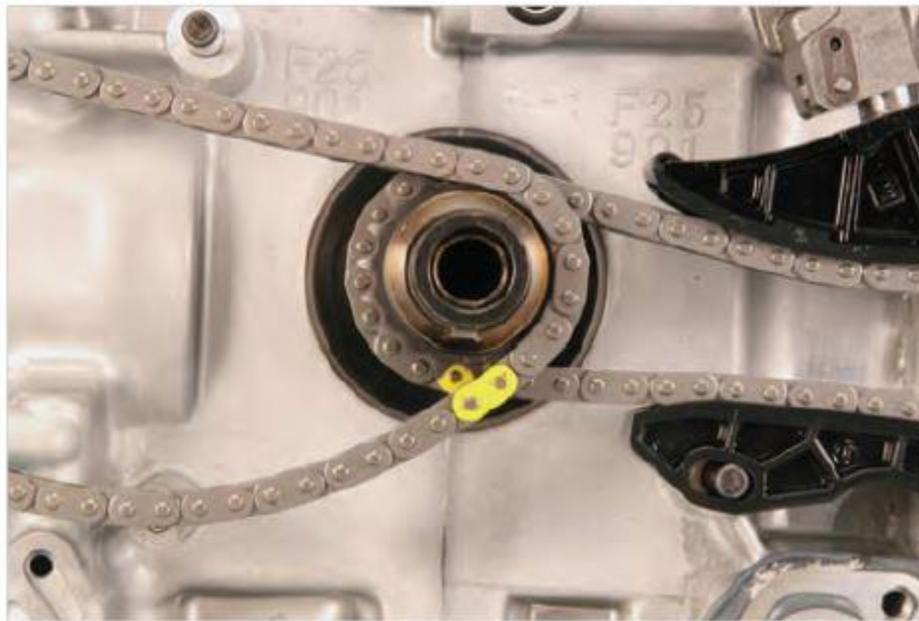
- Align the indicator link with the timing mark on the crankshaft sprocket as shown below.

indicator link with the timing mark on the crankshaft sprocket

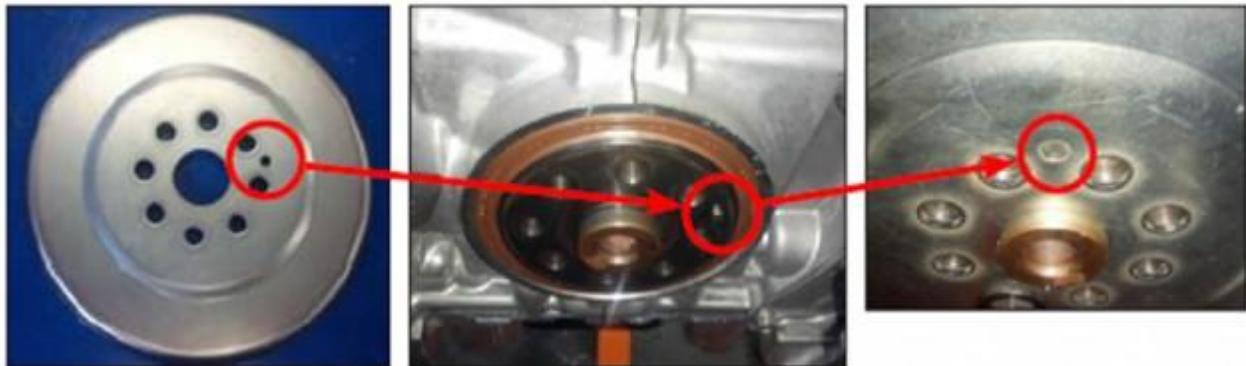
- **REMINDER:** When replacing the short block, in addition to transferring the crankshaft position sensor, be sure to index the reluctor properly onto the crankshaft as shown in the photos below. The reluctor is indexed by a dowel pin in the rear crankshaft flange which aligns with a corresponding hole in the reluctor. It is possible to install the reluctor without indexing it correctly. Failure to index the reluctor correctly will result in a no-start condition due to an out of time crank position signal to the ECM.

dowel pin in the rear crankshaft flange
