SERVICE BULLETIN

APPLICABILITY: 2013-14MY Legacy and Outback Models
 with 2.5L FB Engines
 2011-14MY Forester Models with 2.5L FB Engines
 2015 MY Forester (Manual Transmissions Only)
 with 2.5L FB Engines
 2012-13 MY Impreza and XV Crosstrek Models
 with 2.0 FB Engines
 2014-15 MY Impreza and XV Crosstrek Models
 (Manual Transmissions Only) with 2.0 FB Engines

NUMBER: 02-157-14R

SUBJECT: Surface Treatment Change To Oil Control
 Piston Rings

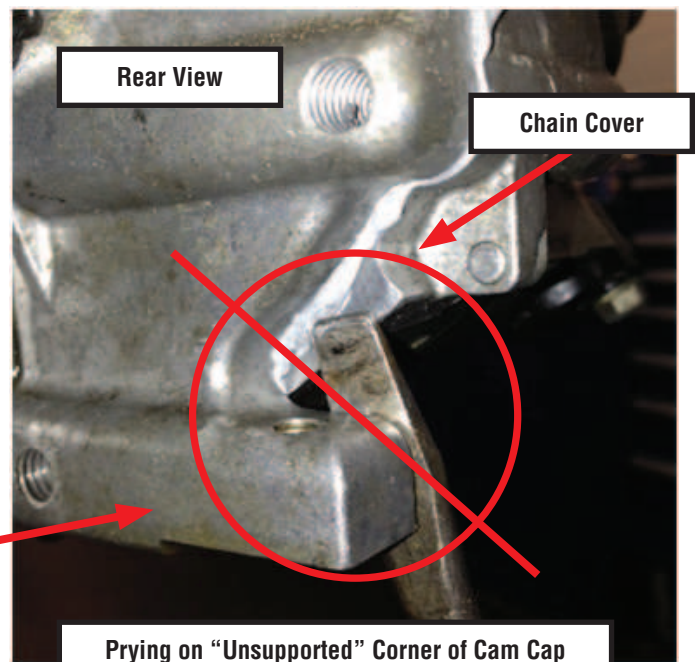
- There is no need to remove the oil dipstick tube or the original oil filter from the front chain cover. While the cover is removed, store it face (front side) down to minimize the chances of damaging the machined sealing surface on the block / head side. Also, don't use it as a tray to store other removed parts.
- **IMPORTANT:** After all 32 bolts securing the chain cover are removed, be **EXTREMELY** careful where you pry and what you pry on to break the silicone sealant's bond. The photos below show an example of where **NOT** to pry. In this case, the cam cap became cracked requiring a complete cam carrier replacement. *Patience is the key!*
